WEAR MECHANISMS OF VALVES AND VALVE SEAT INSERTS IN A GAS-FIRED RECIPROCATING ENGINE

**P. I. Lacey
S. M. Hsu
R. S. Gates
S. Lee
L. Ives
C. Ku
P. Pei
Y. Wang
E. P. Whinton
R. G. Munro**

June 1990

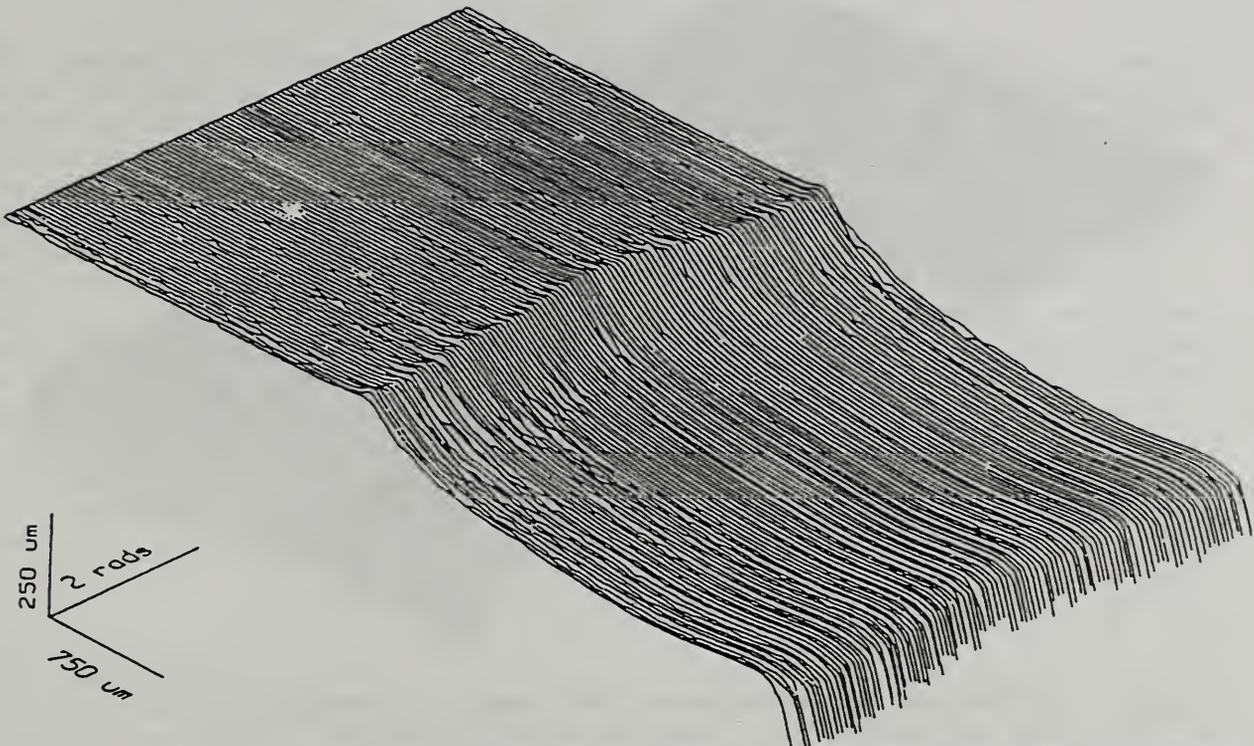
Fig. 2: Surface Map From Around The Complete Circumference of Base Line Valve 2-3.

To facilitate visual analysis of the wear scar, these radial surface profiles were transformed into a pseudo-cartesian coordinate system as shown in figures 2 and 4. Traces taken from the remaining specimens are plotted in appendix 1. Each individual trace represents a radial profile across the contact area, with the valve stem located at the left of the figure. Each surface map depicts one complete revolution of the valve, so that the first and last traces come from the same point. To further simplify the data, the average wear scar profile for each of the valves was calculated from the surface traces in the 3-D wear maps, as depicted in Figs. 3 and 5. This view shows the average shape of the wear scar around the valve. Profile maps for all of the valves are presented in appendix 2.

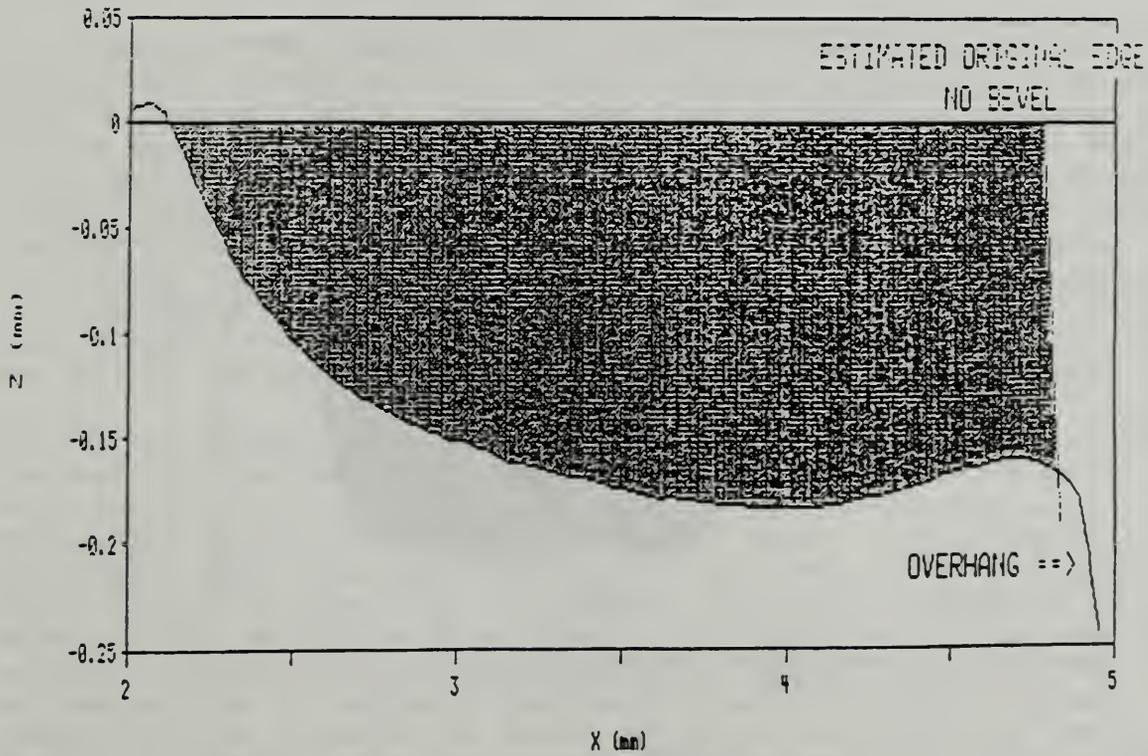
Fig. 3: Average Cross Section of Wear Track on Valve 2-3.

Wear of the ceramic valve seat inserts was negligible, thus the contour of the wear scars on the mating valves corresponds to the profile of the unworn seat. For the baseline case, however, due to the combined deformation of both the valve and valve seat insert, wear is biased towards the outside edge, completely removing the outer bevel from the intake valve as illustrated in Figs. 2 & 3. An interesting feature visible on several valves, is the deposition of material at the inside edge of the wear scar, as shown in Figs. 4 & 5. Examination of this deposit using the SEM microscope (Fig. 6) indicated that severe plastic flow had occurred, resulting in the extrusion of metal from inside the contact to form the lip. It is possible that the extreme conditions produced by the accidental

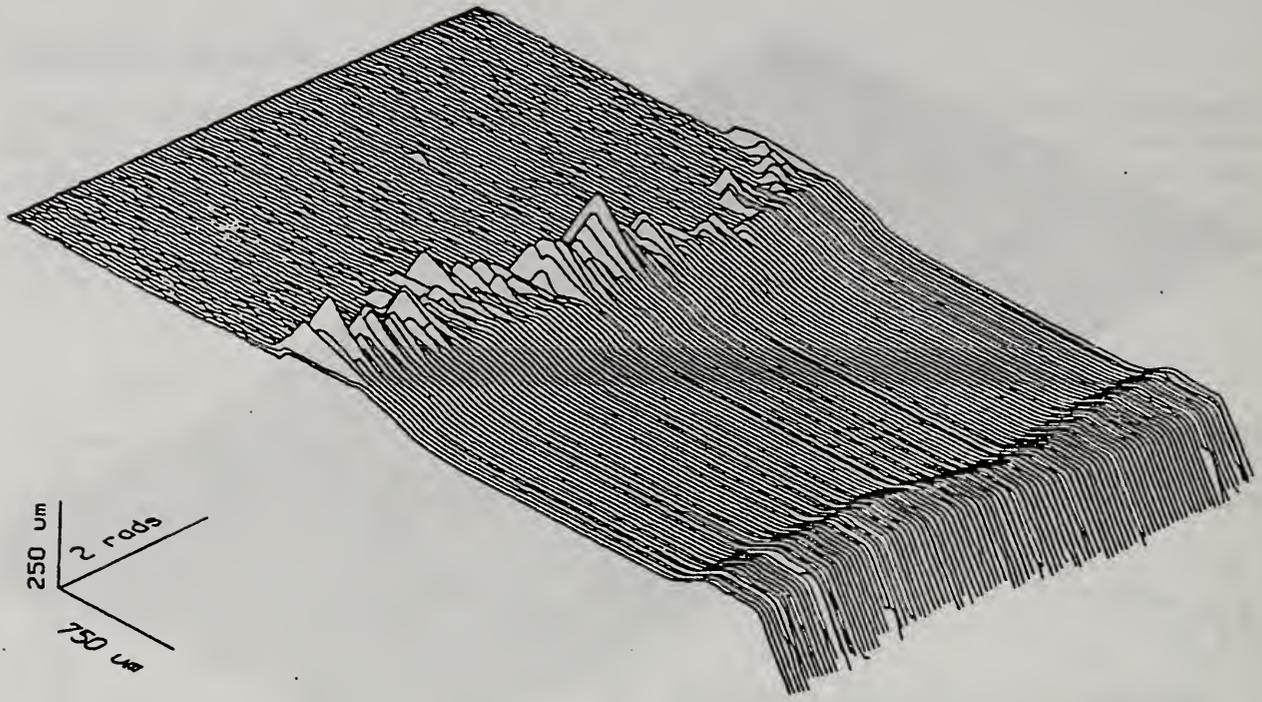
Fig. 4: 3-D Surface Map From Around The Complete Circumference of Valve 1-7.

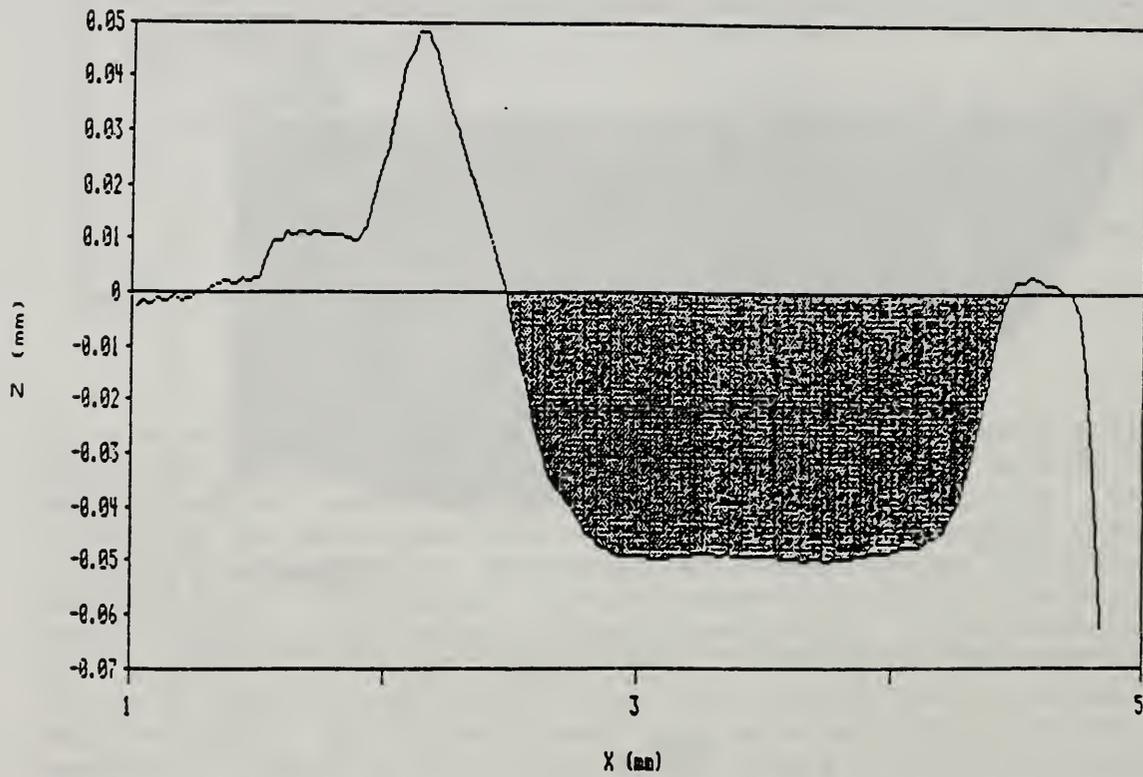
Fig. 5: Average Cross Section of Wear Track on Valve 1-7.

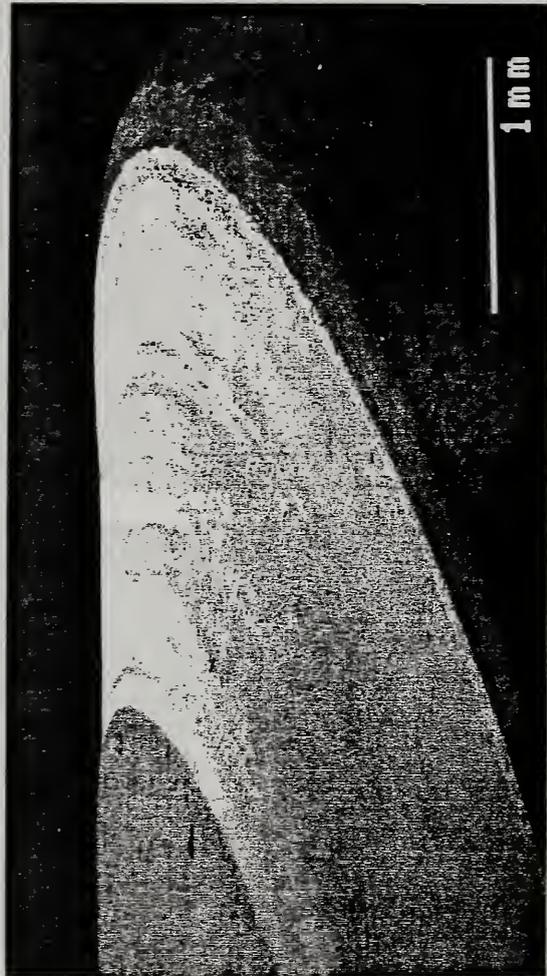
TRIBALLOY-800 EXHAUST VALVE
(vs. SIALON)

overspeed which prematurely concluded the engine test contributed in a significant way to generating the damage. Similar features are visible on the Triballoy 800 inlet valve shown in Fig. 7. In contrast the Triballoy 800 exhaust valve shown in Fig. 8 has a relatively smooth and unworn surface by comparison. Note the layer of deposit which is clearly visible on the valve face.

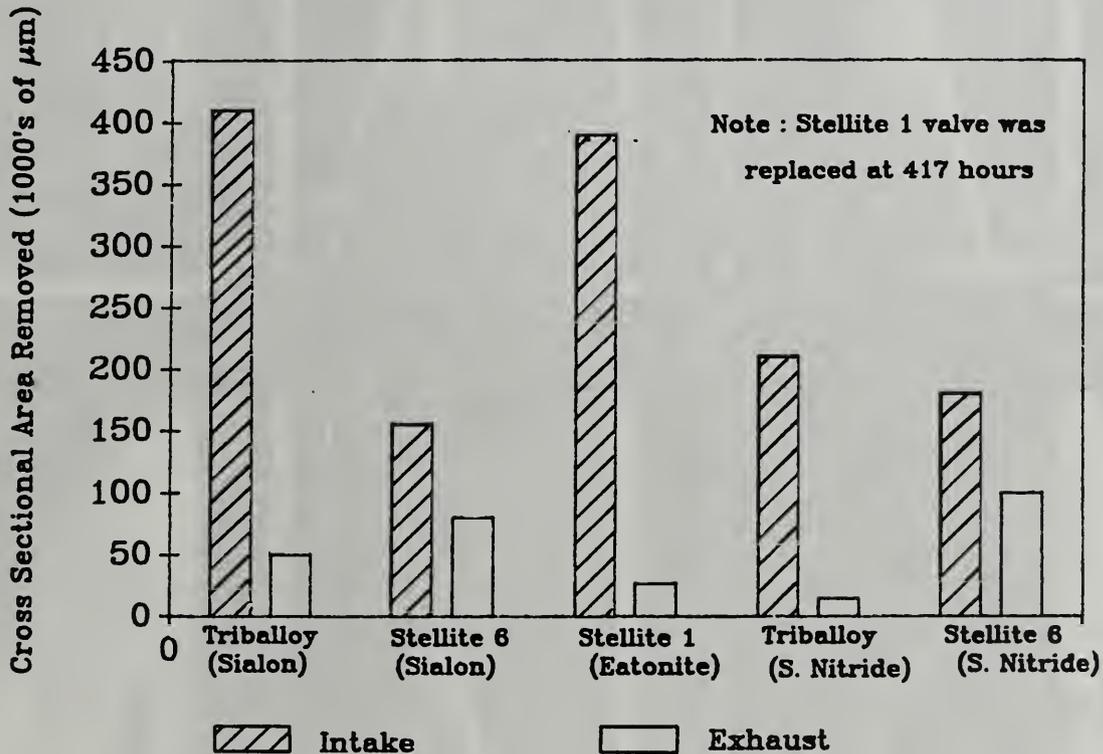
Figure 9: Comparison of Wear Volume of Different Valves/Seat couples

The Stellite 1/Eatonite couple were replaced after 417 test hours and hence only experienced 164 hours of operation. Despite this the wear volume was still comparable to that of the remaining valves, which remained in the engine for the entire 581 hours. Therefore, all of the advanced materials tested are more durable than the baseline materials, which are the current

industry standard. Tribaloy 800 run against a silicon nitride seat was the most successful exhaust valve material, but was marginally less effective than Stellite 6/sialon when used as an intake valve. The results from this test indicate that material combinations which produce low wear as inlet valves are not necessarily successful as exhaust valves. The optimum solution may require different material combinations, depending on whether the valve is to be used as an intake or an exhaust. For each of the material combinations used, the wear rate of the intake valves is much greater than that of the exhaust. This is contrary to the normal result for gasoline and diesel engines, where additional lubrication of the intake valves is provided by additives or by the high molecular weight species present in the fuel.

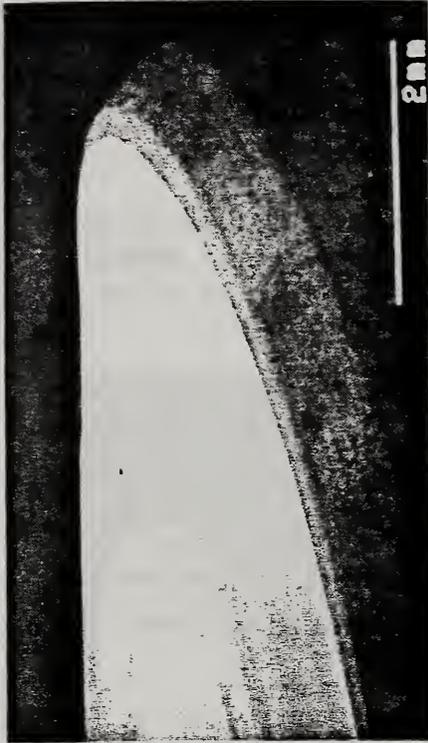
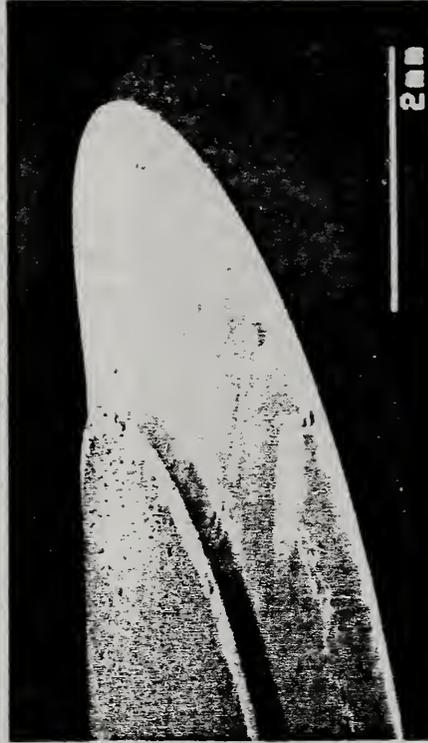
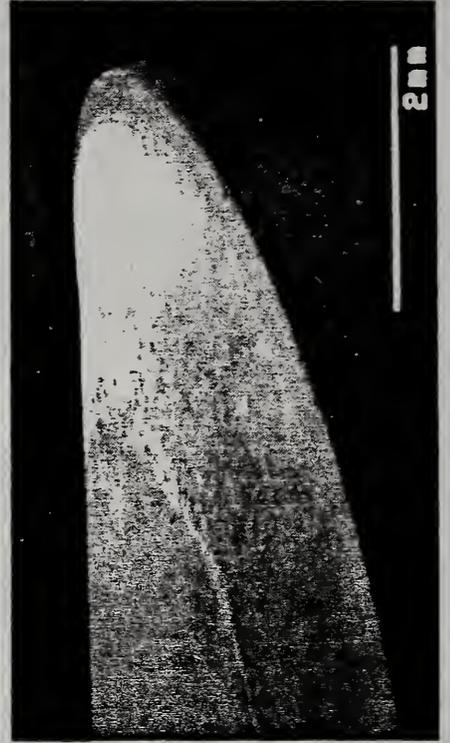
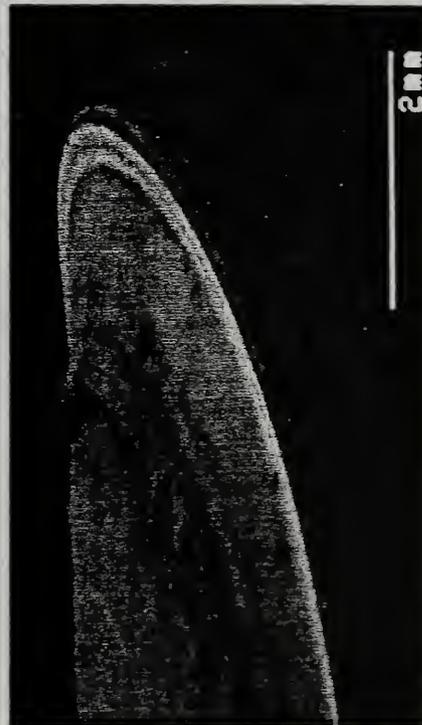
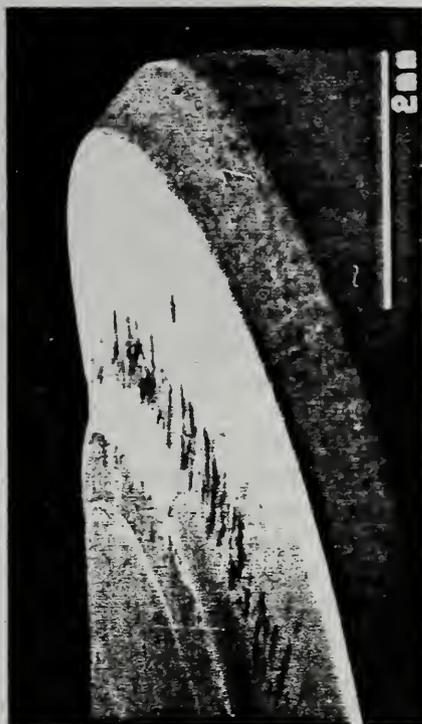
Photographs of the worn surfaces from each of the valves are shown in Figs 10 and 11 for comparison. All of the Stellite 6 and Tribaloy 800 valves coupled with ceramic seat inserts are smooth and free of pitting, although gross plastic flow has taken place towards the inside of the seat on the intake valves. The surface of the Stellite 1 valve is rough by comparison, probably because the Eatonite counterface is relatively soft compared to ceramic, hence compliance is not confined to the valve face.

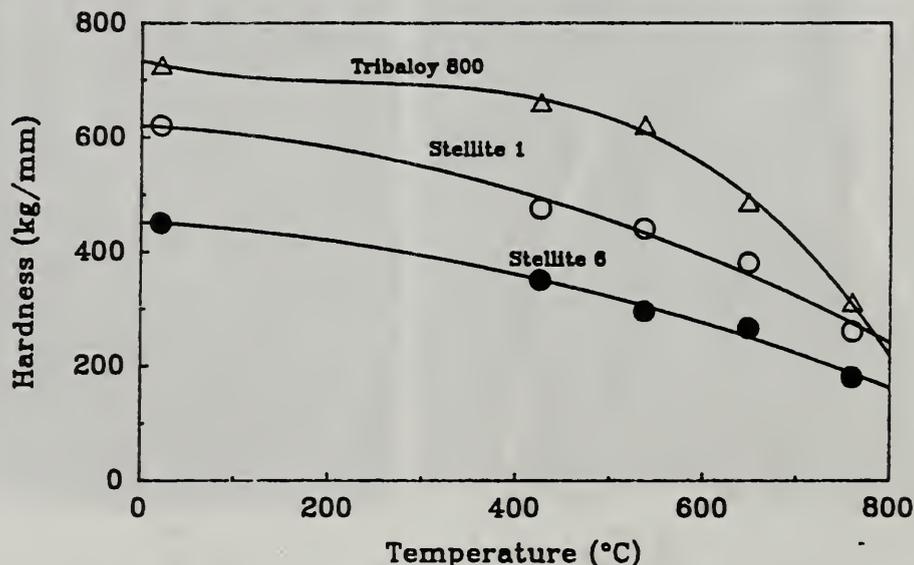
Hot Hardness tests were conducted in an attempt to explain the observed wear characteristics of the various materials. The hardness of each of the valve facings is plotted in Fig. 12, as a function of temperature. For the range of temperatures examined Tribaloy 800 is considerably harder than either Stellite 1 or 6. However, in the present test no direct correlation exists between hot hardness and wear, indicating that perhaps other parameters such as fatigue strength, fracture toughness, and surface chemical reactivity may be important. Further detailed laboratory tests are necessary to examine this result.

Figure 12: Hot Hardness of Alloy Materials

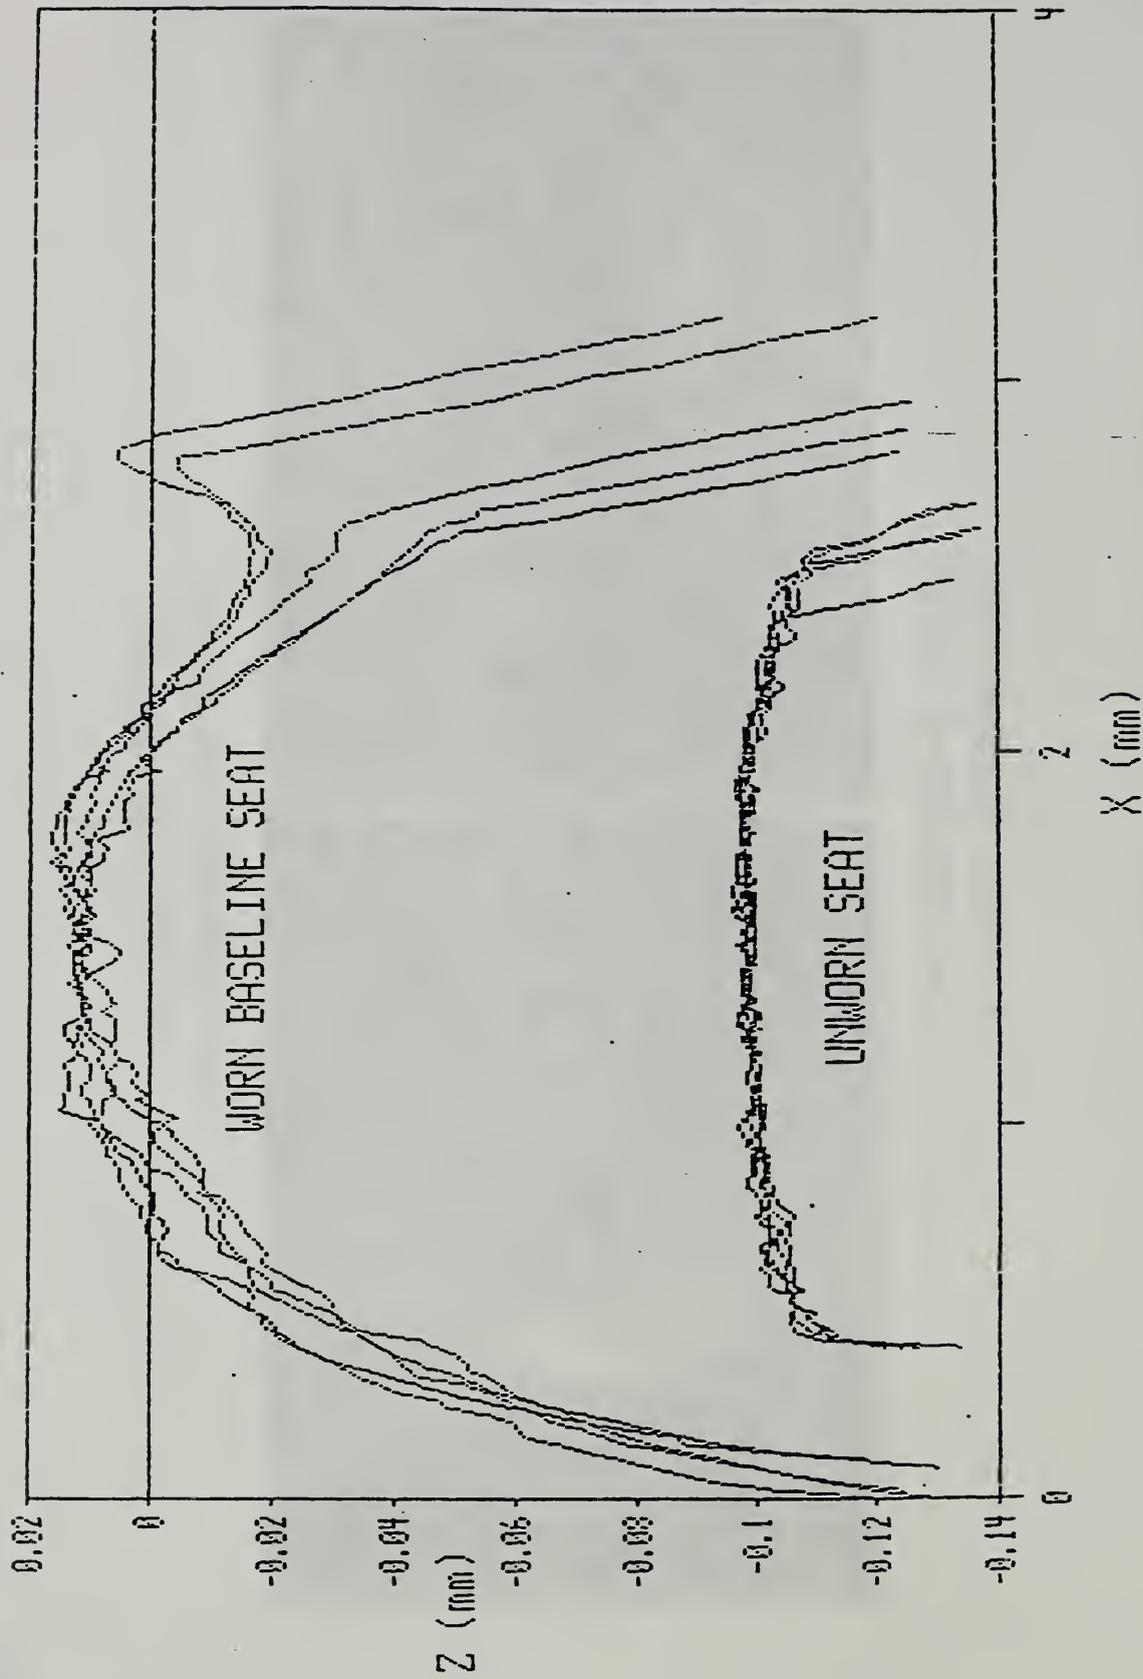
Figure 17: Profiles from both worn and unworn eatonite (baseline) valve seats
 (Note that the profile of the unworn seat is displaced downwards for clarity.)

The dimensions of the ceramic valve seats were still within the originally specified tolerance, so no measurable wear existed, representing a major improvement over the Eatonite (baseline) seats which were worn and had lost their original shape.

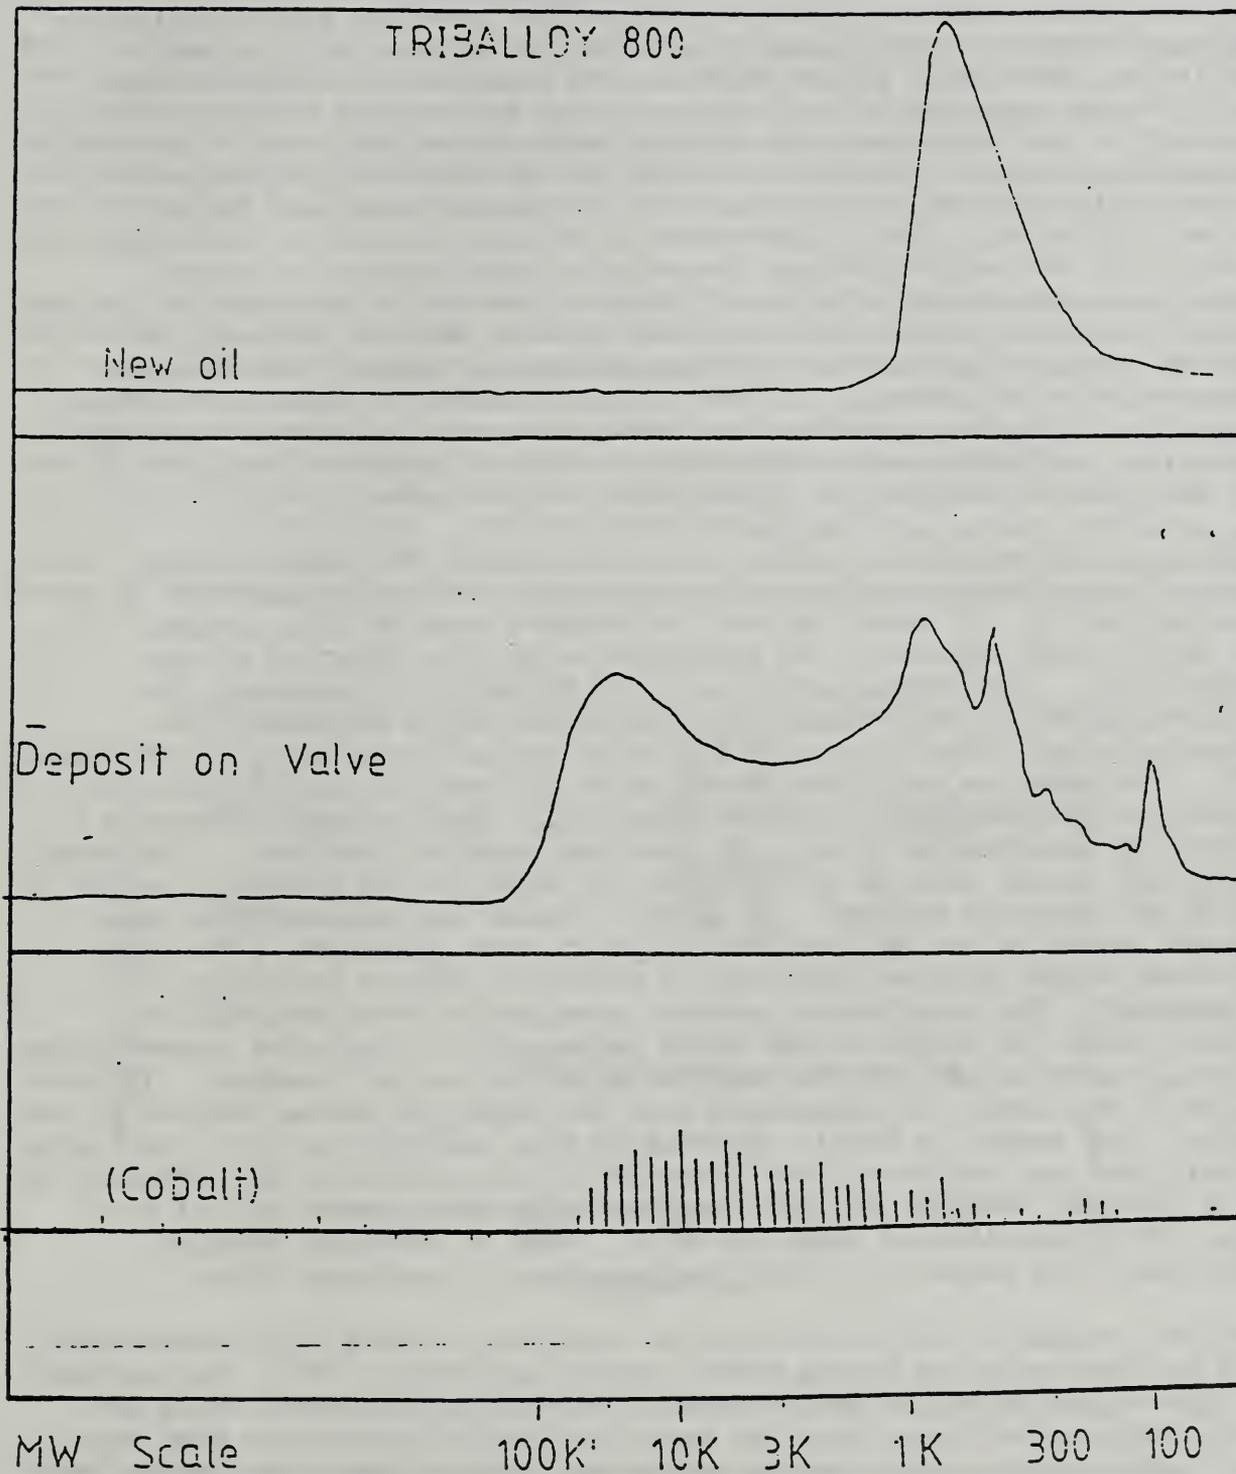
Fig. 25: GPC/GFAA Analysis of Deposits Dissolved From The Surface of Triballoy 800 Valve

GPC is a liquid chromatographic technique that provides semi-quantitative information on the molecular size distribution of species in a sample. Applied to lubricants, it can indicate the approximate molecular weight distribution of lubricant oxidation products and provide insight on the severity of the environment to which a lubricant is subjected. One unique capability of the GPC apparatus at NIST is the ability to determine the concentration of metals associated with species eluting from the GPC column⁵ (GPC-GFAA). This information is valuable because it indicates the severity of the metal-lubricant interaction with respect to surface corrosion. Many metals will react chemically with the lubricant to produce metalo-organic compounds. To a limited extent, this is necessary to provide adequate lubrication. In some instances however, the chemical interaction is too strong, and the lubricant serves to chemically attack the surface, leading to corrosion of the surface and a loss of structural integrity. GPC-GFAA analysis has the capability of determining whether or not the chemical interaction is adequate, or corrosive.

Lubricant oxidation and polymerization reactions require high temperatures, such as those existing during normal engine operation. Thus, the presence of high molecular weight species on the valves, as determined using GPC-GFAA analysis, indicates that the deposits found on the valves must have been formed in the engine during operation. This supports the contention that some oil must have reached the valve head during operation, either by descending the valve stem, or as vapor produced by lubricant evaporating from the cylinder walls.

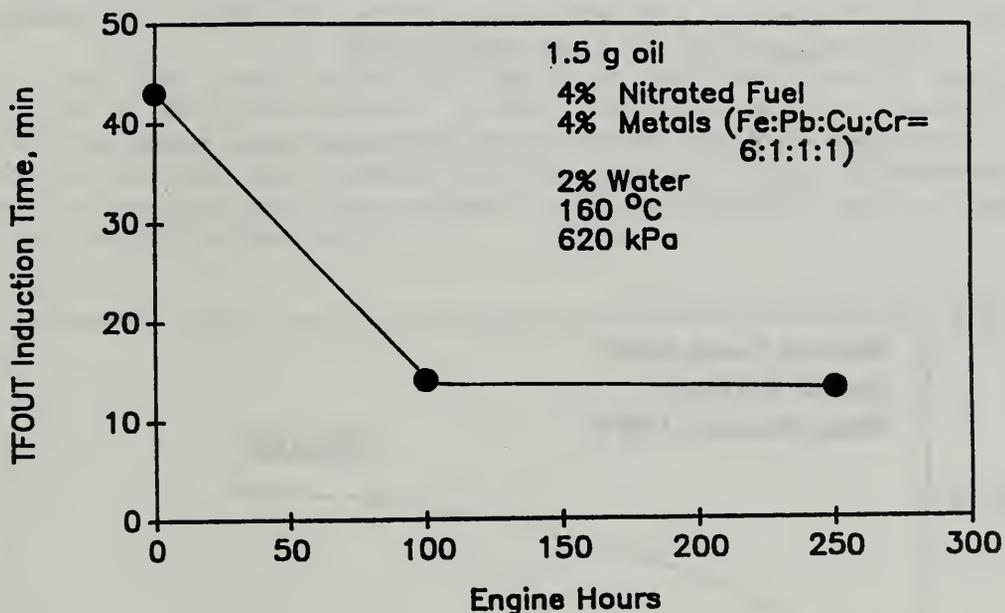
The Thin Film Oxidation Uptake Test (TFOUT - ASTM D4742, 1989) measures the oxidation induction time of the lubricant under conditions which simulate the high-temperature oxidation processes in reciprocating engines. This test was carried out on a selection of oils from the initial 250 hour cycle in order to determine whether the oxidation stability of the oils had been significantly affected by its use in the engine. Samples of used oil taken at 100 and 250 hours were examined using TFOUT and the results compared to the unused oil (Fig. 26). The oxidation induction time after 100 hours of engine use is only 25% of that for the new oil, therefore engine operation seems to have significantly reduced the oil's oxidation stability.

Figure 26: Results of TFOUT tests on new and used engine oils

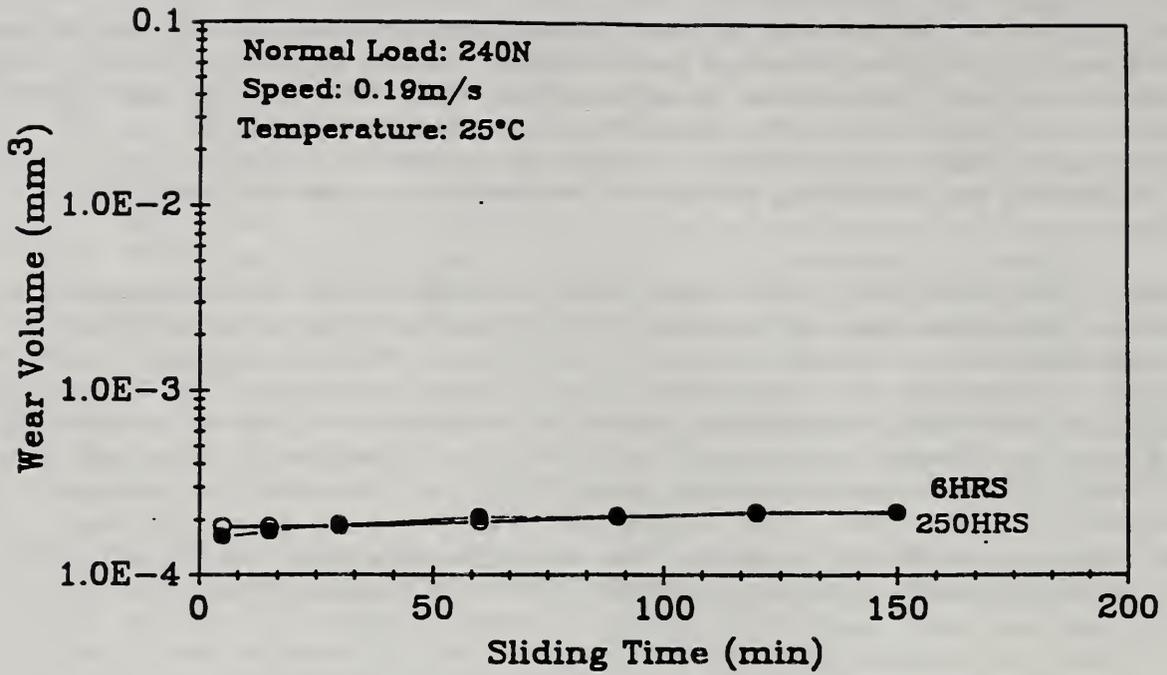
Fig. 27: Wear Volume as a Function of Sliding Time for Si₃N₄ Lubricated With Pegasus-485 at Room Temperature.

For tests carried out at 25°C lubricant degradation has little effect on wear, as illustrated in Fig. 27. The two lines coincide almost exactly and little wear occurred over the complete test duration for either 6 hour or 250 hour oil. To gauge the effect of temperature on the wear process, the above tests were repeated at a bulk oil temperature of 175°C. The wear observed with both oils (Fig. 28) has increased above that measured at 25°C, however, the 250 hour used oil has significantly higher wear than the 6 hour oil.

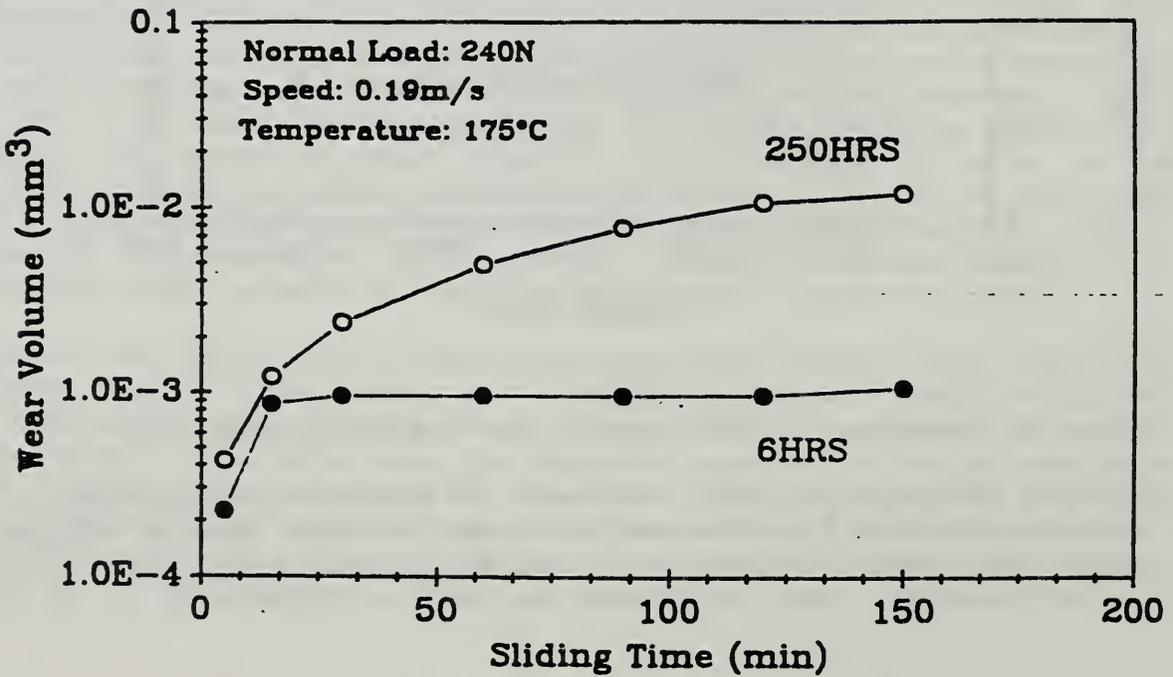
Fig. 28: Wear Volume as a Function of Sliding Time for Si₃N₄ Lubricated With Pegasus-485 at Elevated Temperature.
